Parcel C (Parcels C and UC-2)
Five-Year Review Site Inspection Photograph Locations
Five-Year Review of Remedial Actions
Hunters Point Naval Shipyard, San Francisco, California

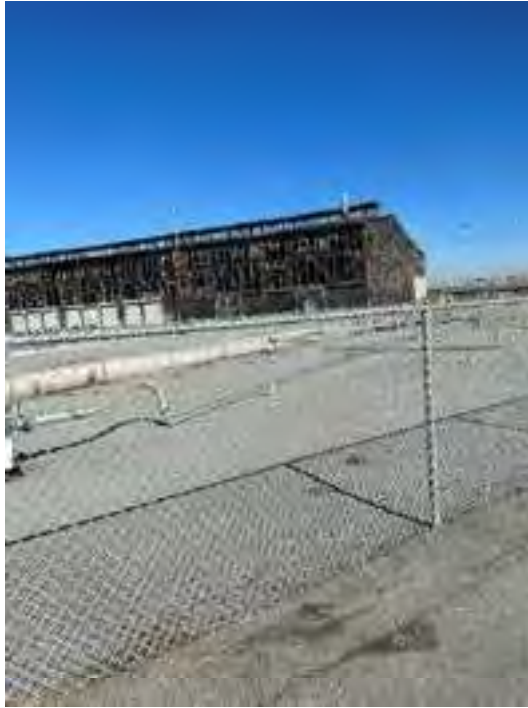
Parcel C Photograph 5: SVE treatment systems surrounded by chain-link fence. Facing northwest.

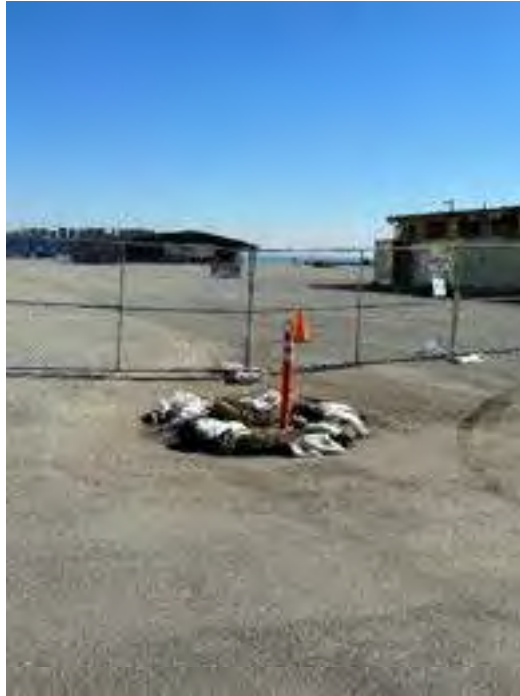
Parcel C Photograph 9: Stormwater best management practices around catch basins during active trenching work. Facing northwest.

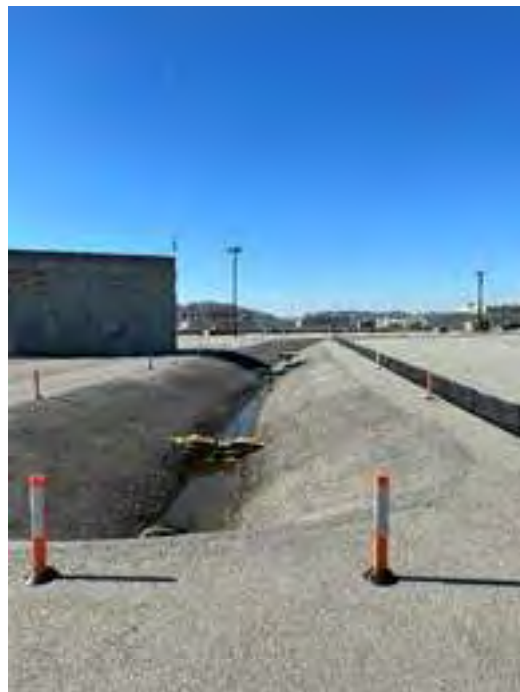
Parcel C Photograph 10: Paved drainage swale outfall south of Building 230. Facing southwest.

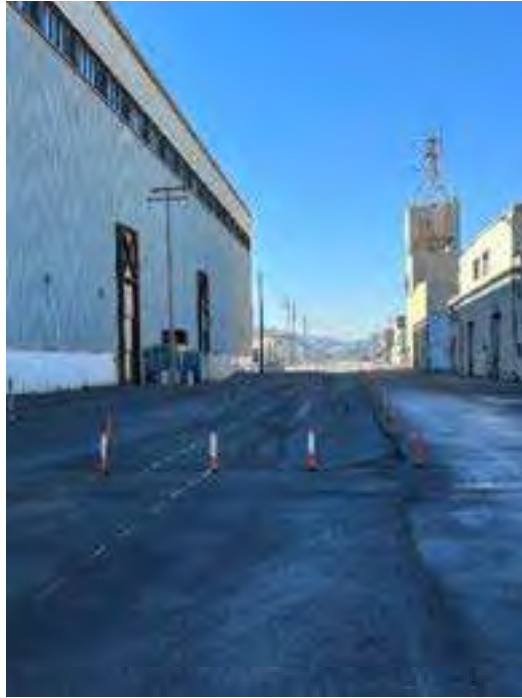
Parcel C Photograph 13: Asphalt paved drainage swale along Spear Avenue between Building 281 and 251. Facing southwest.

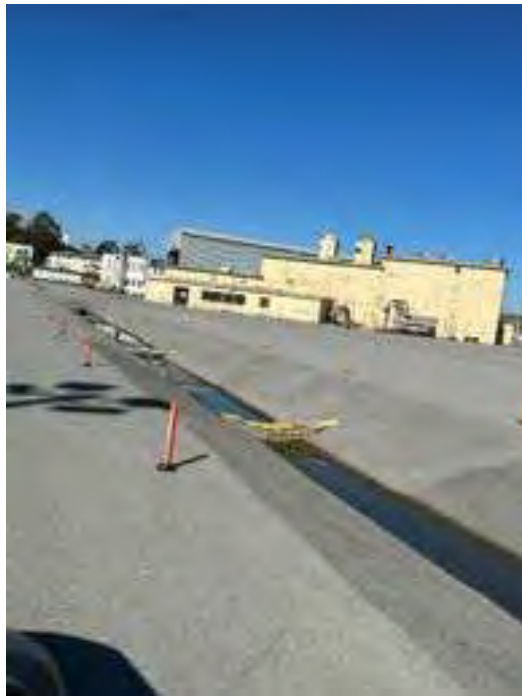
Parcel C Photograph 14: Paved drainage swale southeast of Building 235. Outfall south of Building 234. Facing northwest.

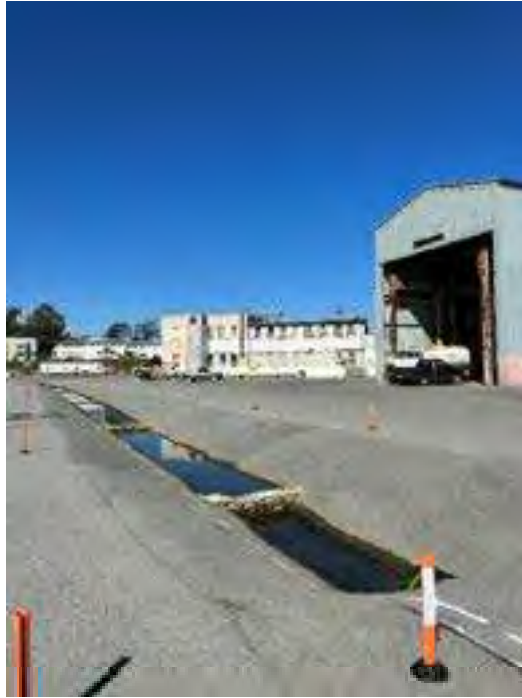
Parcel C Photograph 15: Paved drainage swale southwest of Building 230. Facing northwest.

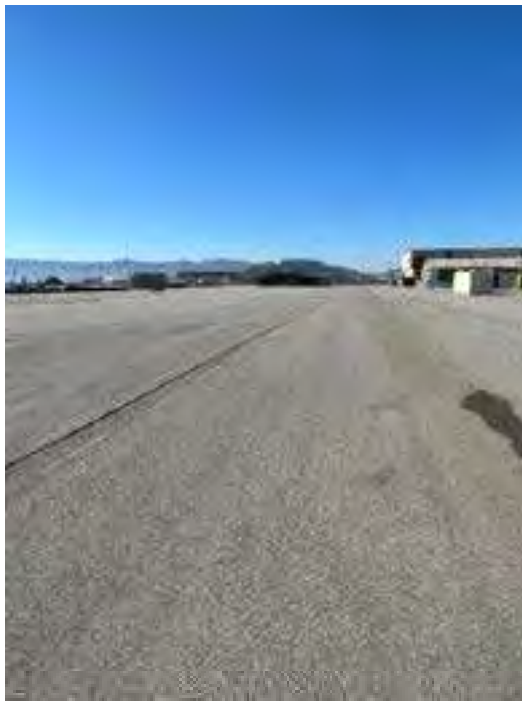
Parcel C Photograph 16: Asphalt pavement cover southeast of Building 228 along Nimitz Avenue. Facing southwest.

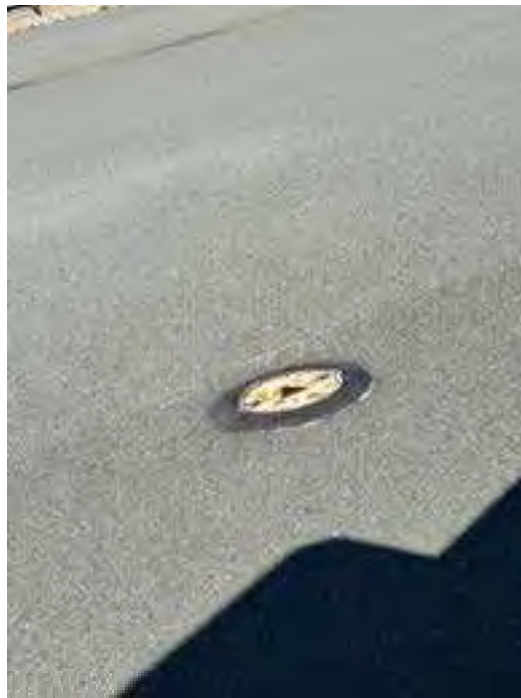
Parcel C Photograph 18: Monitoring well south of Building 271 along Nimitz Avenue. Facing northwest.

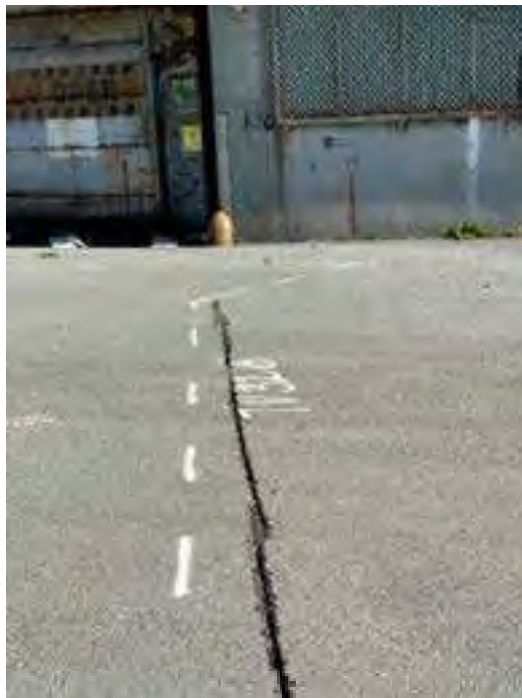
Parcel C Photograph 20: Planned excavation area west of Building 253. Facing east.

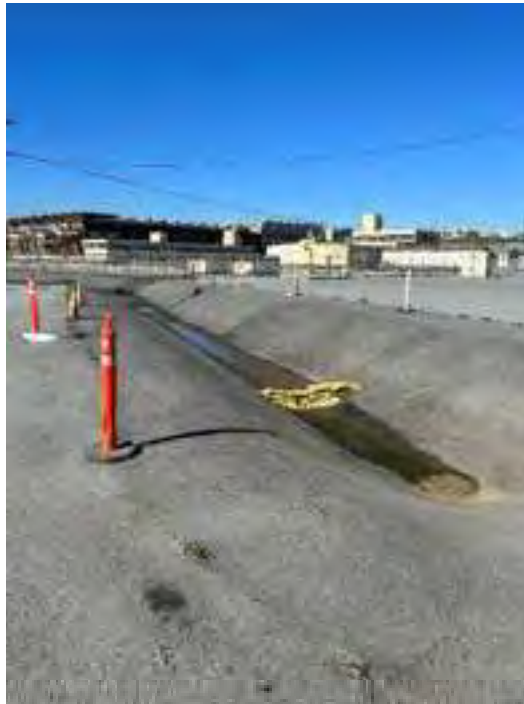
Parcel D-1 Photograph 4: Drainage swale adjacent to Parcel G. Facing southwest.

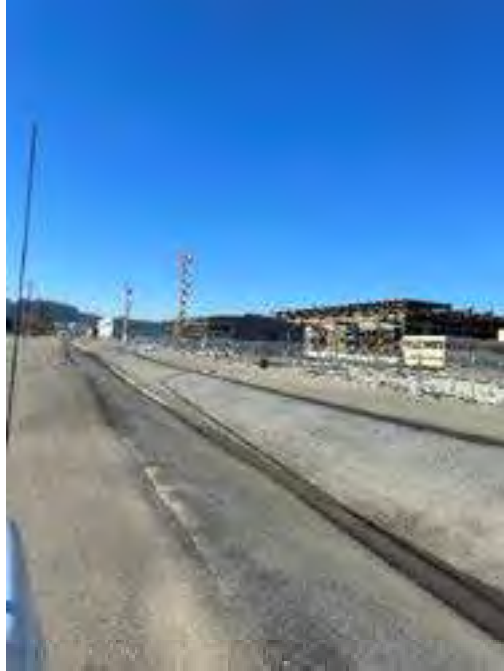
Parcel D-1 Photograph 5: Drainage swale adjacent to Parcel G. Facing southwest.
Photographed by: Marcella Navas/CH2M, 2/9/2023

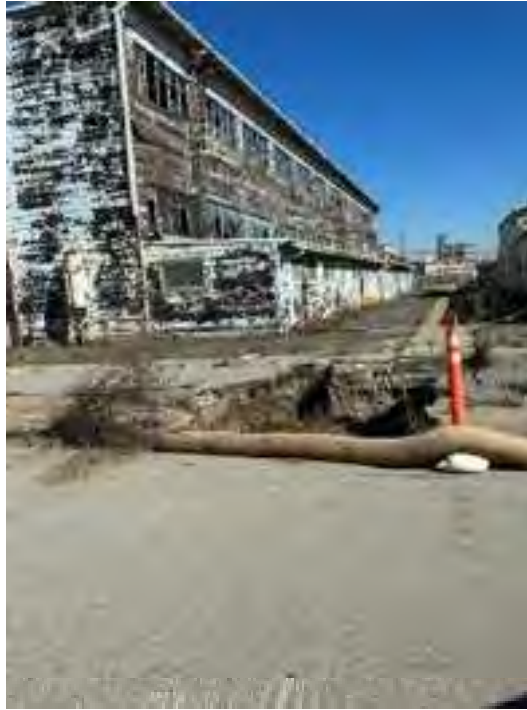
Parcel G Photograph 1: Excavation between Building 302 and 303. Facing northeast.
Photographed by: Marcella Navas/CH2M, 2/9/2023

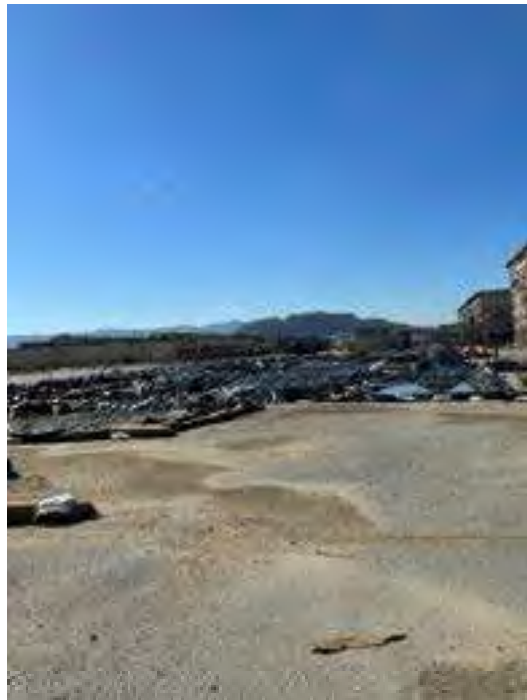
Parcel G Photograph 2: Stormwater best management practice southeast of Building 402. Facing southwest. Photographed by: Marcella Navas/CH2M, 2/9/2023

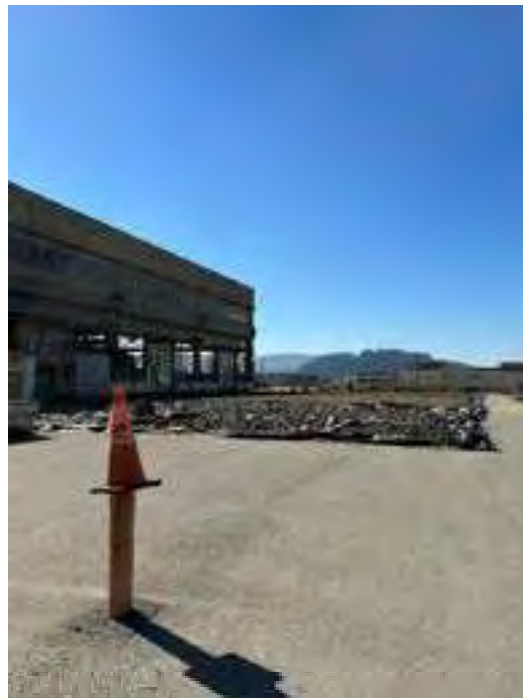
Parcel G Photograph 4: Stormwater best management practice east of Building 418.
Facing southeast.

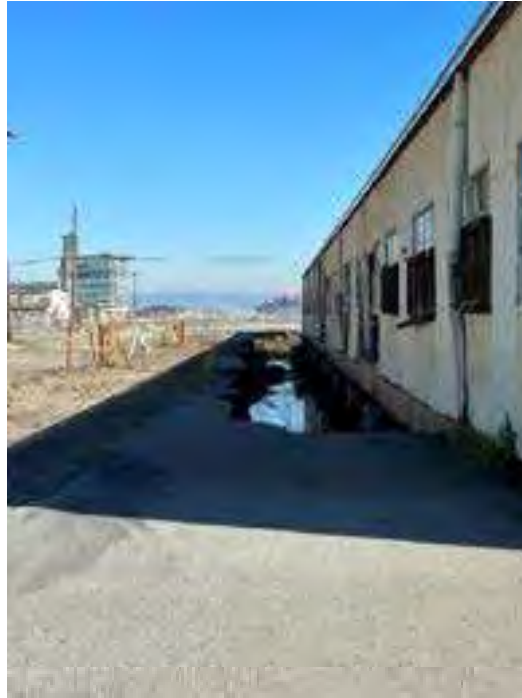
Parcel G Photograph 7: Trenching northwest of Building 363. Facing north.

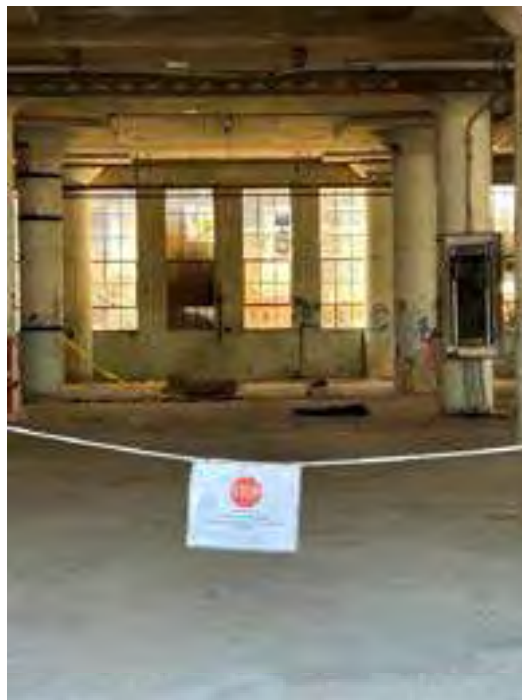
Parcel G Photograph 8: Warning sign outside of Building 351. Facing southwest.

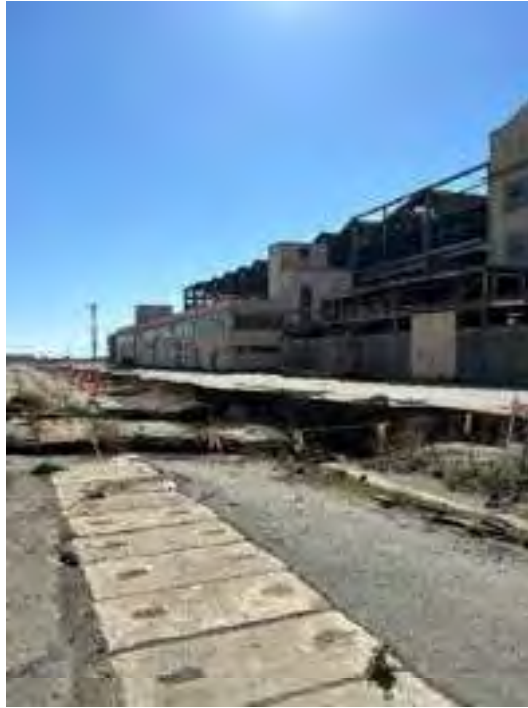
Parcel G Photograph 15: Trenching east of Building 411. Facing southwest.
Photographed by: Marcella Navas/CH2M, 2/9/2023

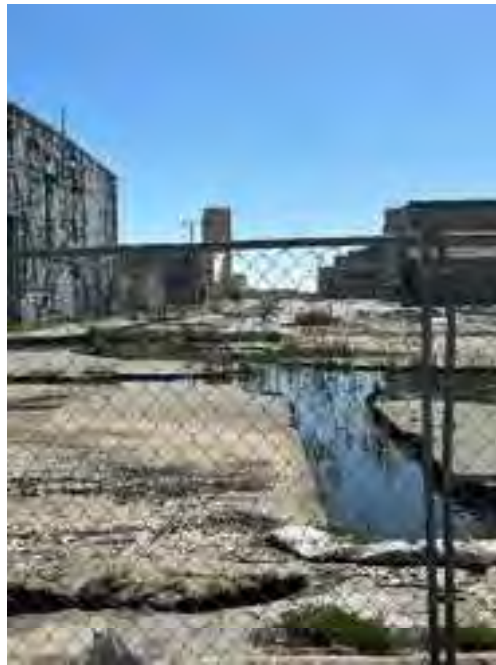
Parcel G Photograph 16: Trenching between Building 402 and 302 within Parcel G from UC-1. Facing southeast.
Photographed by: Marcella Navas/CH2M, 2/9/2023

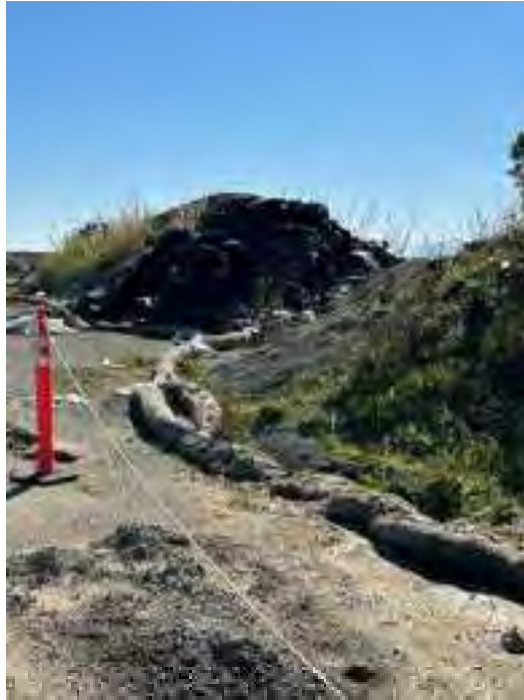
Parcel E Photograph 7: Stockpile near shoreline southeast of J Street. Facing southeast.

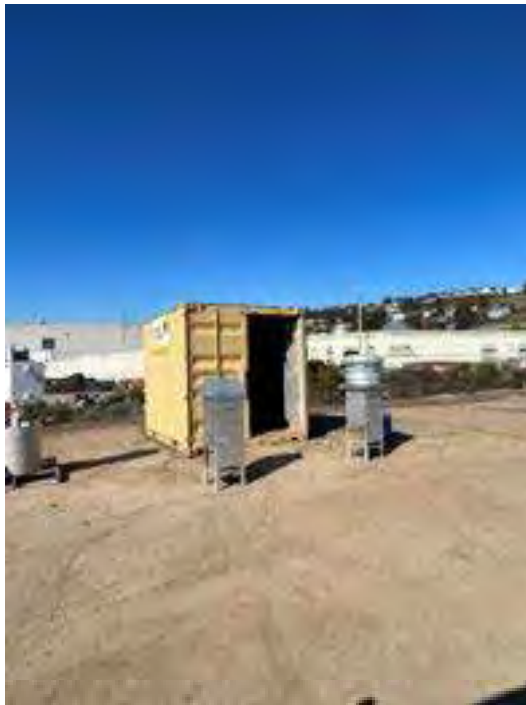
Parcel E-2 Photograph 2: Storage containers onsite for generators. Facing southwest.

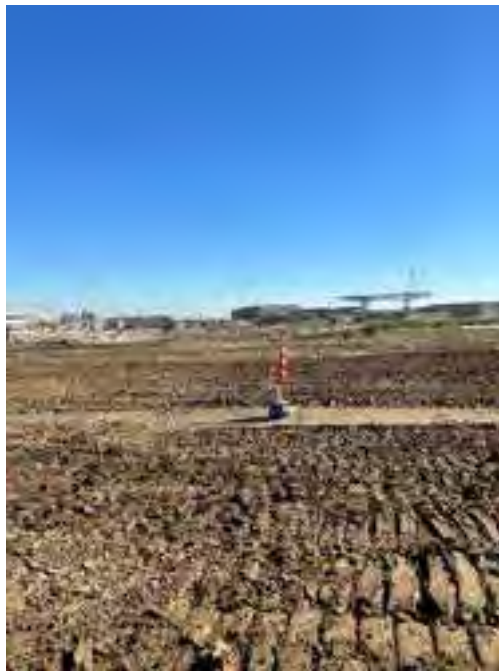
Parcel E-2 Photograph 4: *Graded area with marked monitoring point. Facing southeast.*

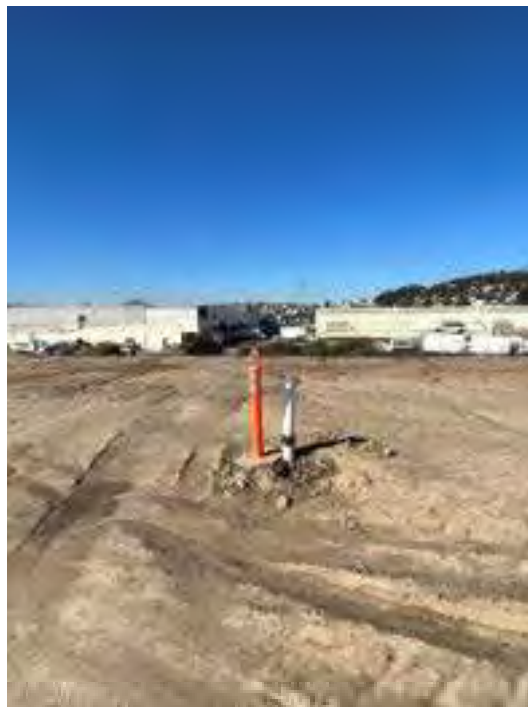
Parcel E-2 Photograph 8: Monitoring well located in soil cover area. Facing southwest.

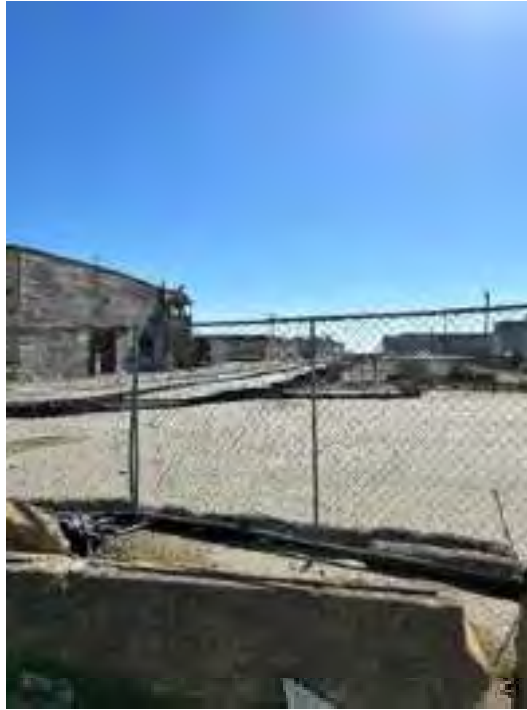
Parcel UC-1 Photograph 1: Chain-link fence along Parcel UC-1 and Parcel G. Facing south.

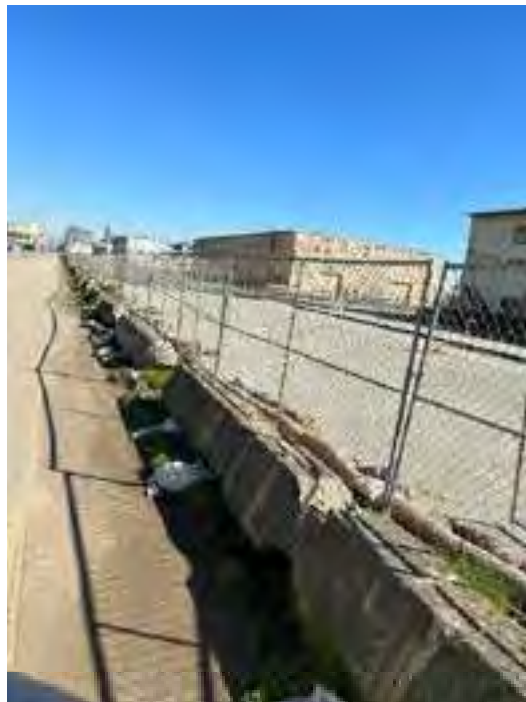
Parcel UC-1 Photograph 2: Chain-link fence along Parcel UC-1 and Parcel G. Facing northeast.

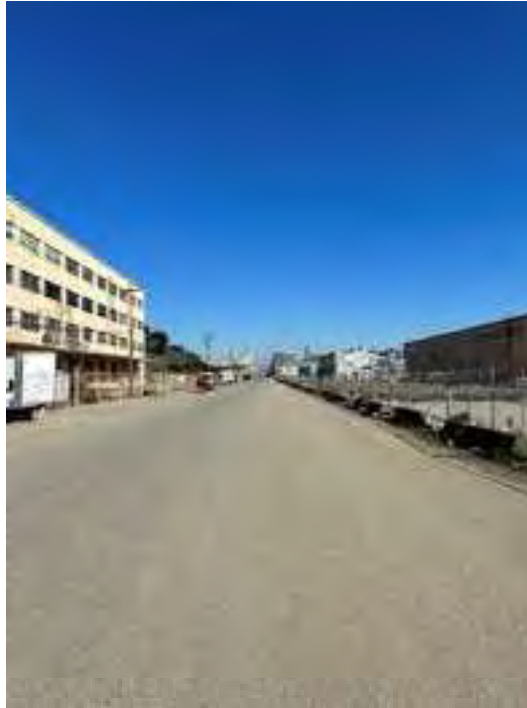
Parcel UC-1 Photograph 3: Asphalt pavement cover along Spear Avenue. Facing northeast.

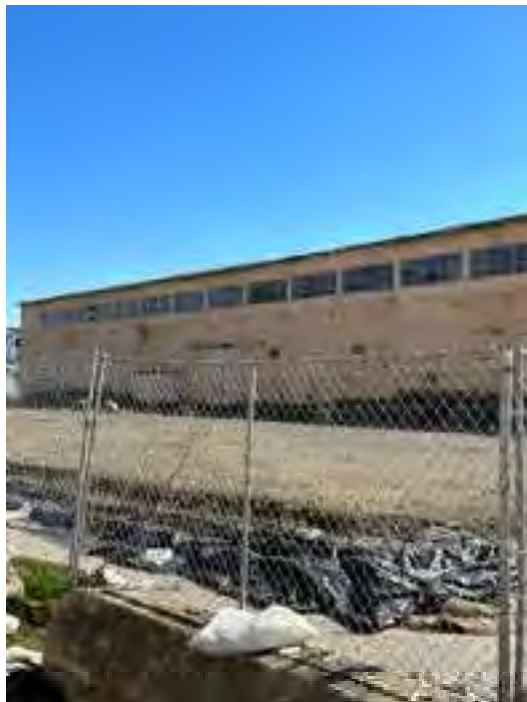
Parcel UC-1 Photograph 4: Chain-link fence along Parcel UC-1 north of Building 402. Facing southeast.

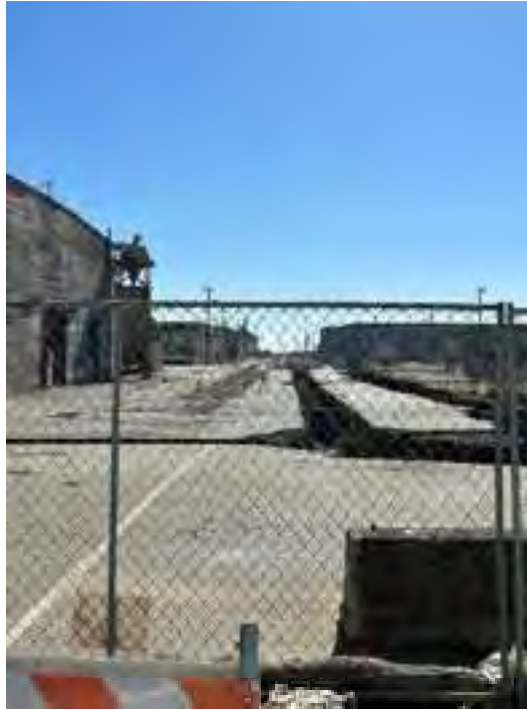
Parcel UC-1 Photograph 5: Chain-link fence along Parcel UC-1 north of Building 401.
Facing southeast.

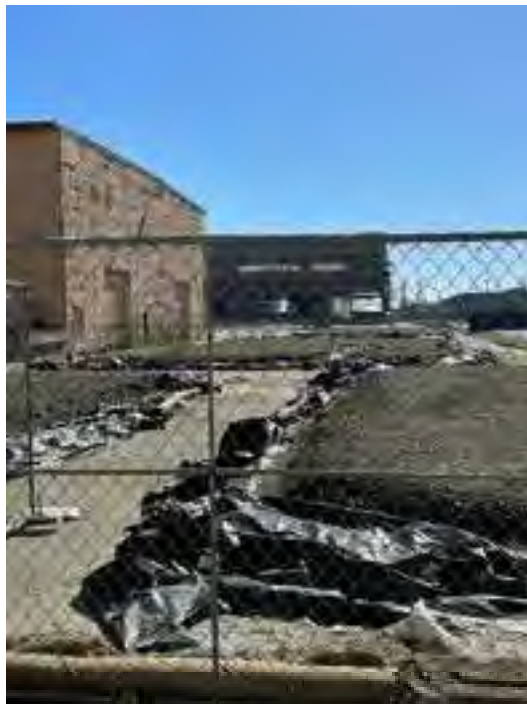
Parcel UC-1 Photograph 6: Chain-link fence along Spear Avenue between Buildings 401
and 402. *Facing south.*

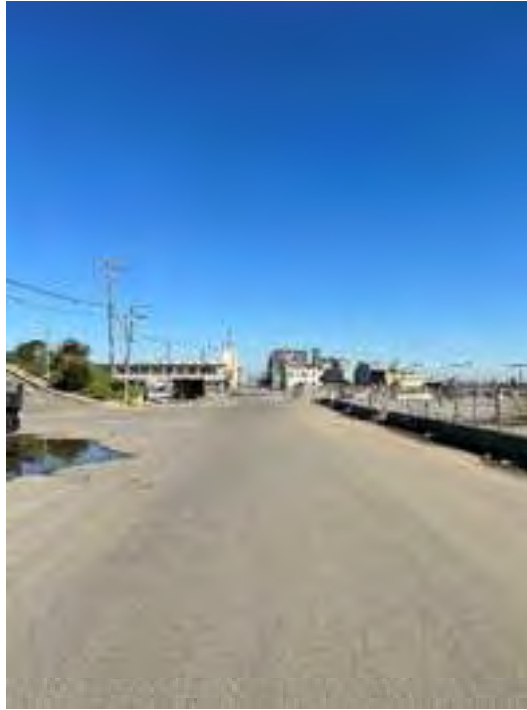
Parcel UC-1 Photograph 7: Asphalt pavement cover between Horn and Spear Avenue.
Facing north.

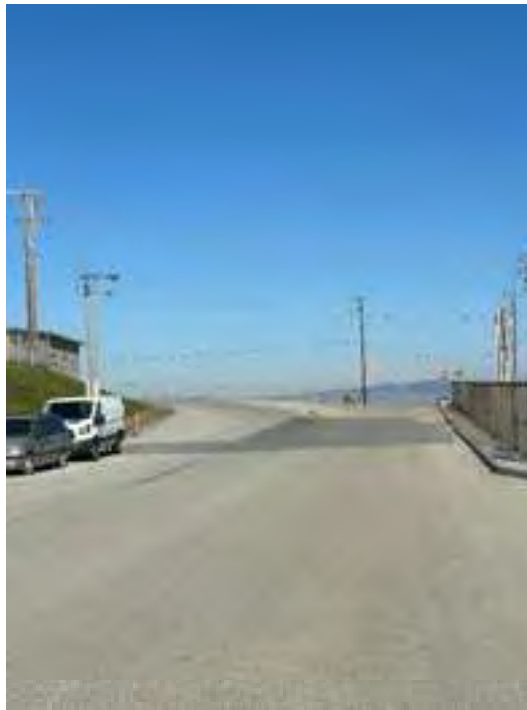
Parcel UC-2 Photograph 1: Asphalt pavement cover along Fisher Avenue. *Facing northeast.*

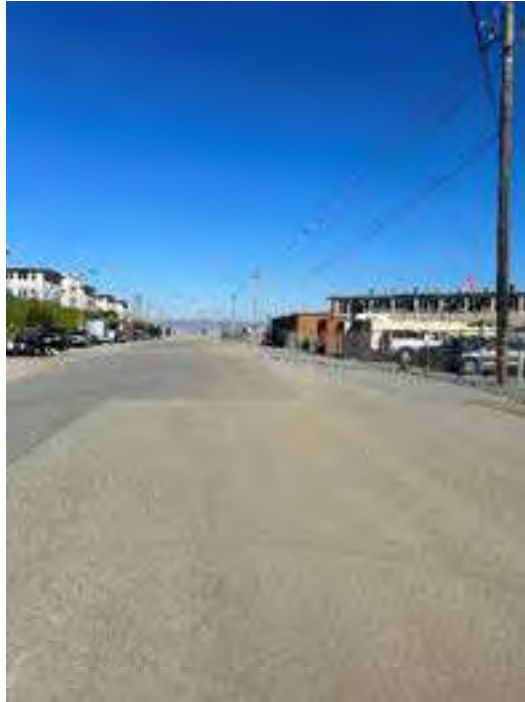
Parcel UC-2 Photograph 2: Asphalt pavement cover along Fisher Avenue. Facing northeast.

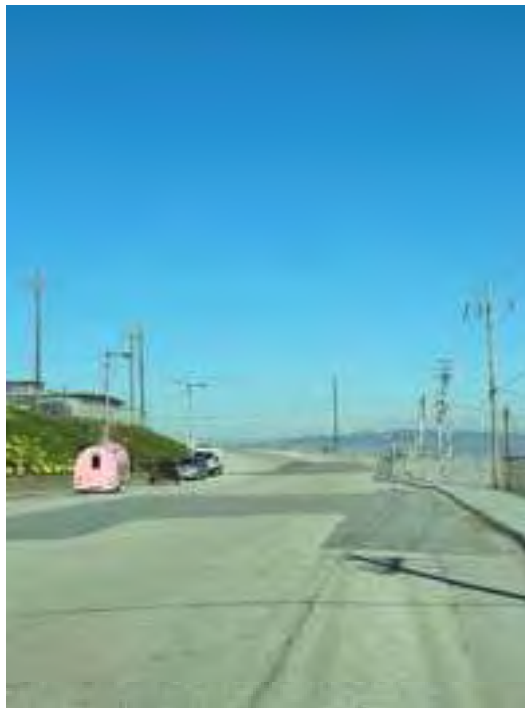
Parcel UC-2 Photograph 3: Asphalt pavement cover along Fisher Avenue. Facing northeast.

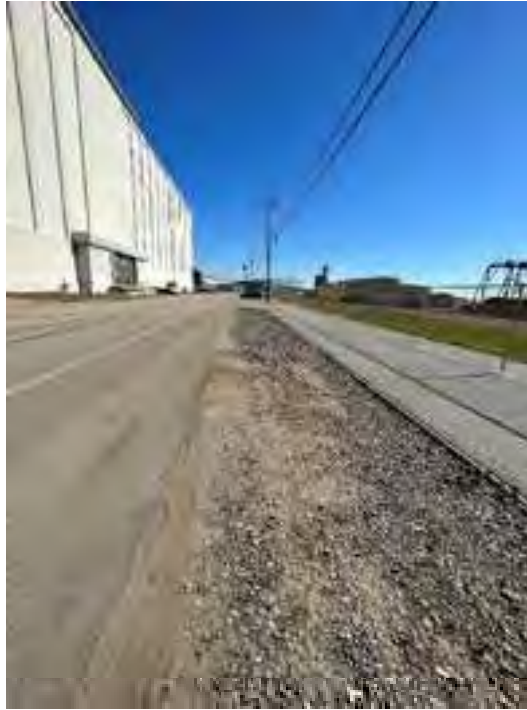
Parcel UC-3 Photograph 1: Gravel located south of Building 815. Facing southeast.
Photographed by: Marcella Navas/CH2M, 2/9/2023

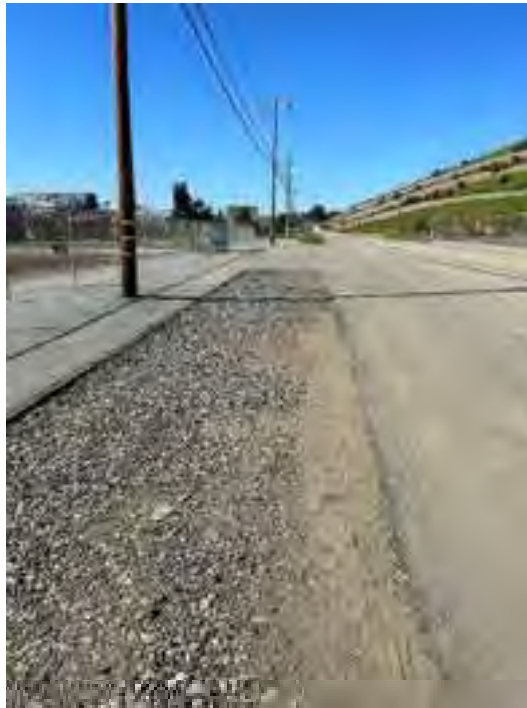
Parcel UC-3 Photograph 2: Gravel located south of Building 815. Facing northwest.
Photographed by: Marcella Navas/CH2M, 2/9/2023

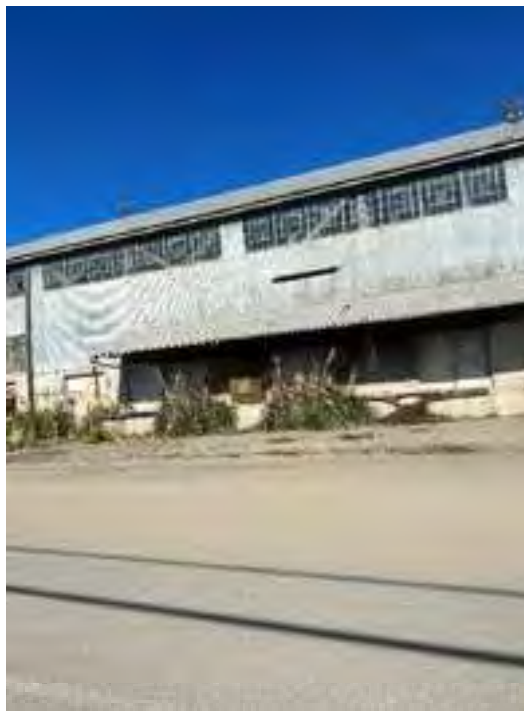
Parcel UC-3 Photograph 3: Overgrowth of vegetation south of Building 815. Facing north.

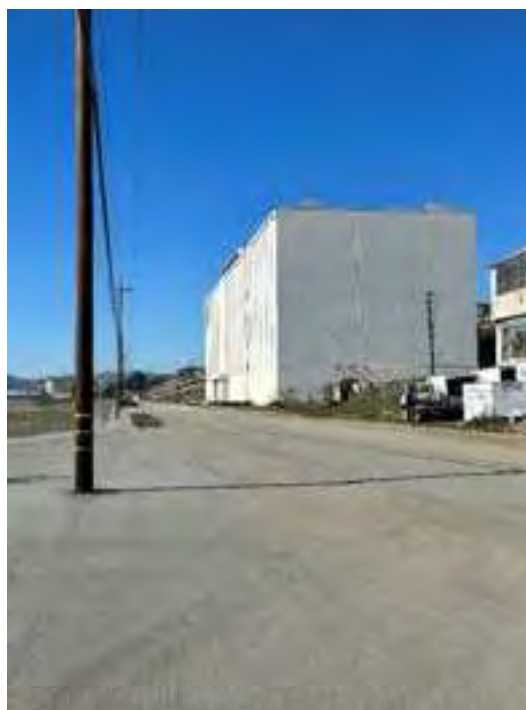
Parcel UC-3 Photograph 4: Asphalt pavement cover southeast of Building 815. Facing northwest.

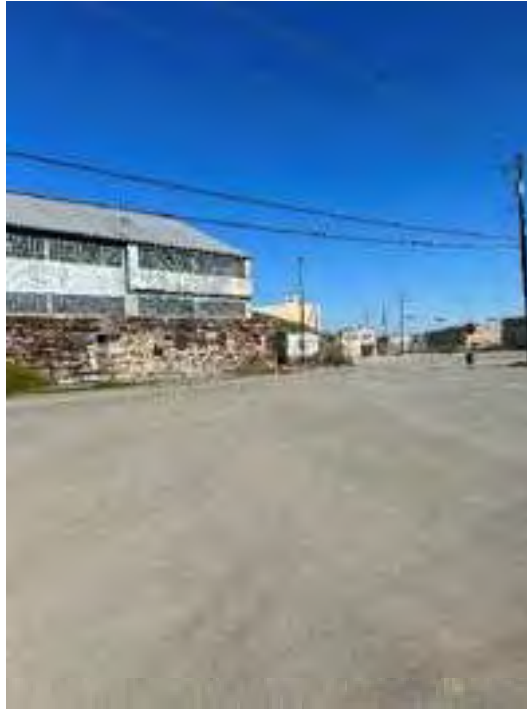
Parcel UC-3 Photograph 5: Asphalt pavement cover southeast of Building 815 located between Parcel UC-1 and Parcel E-2. Facing northeast.

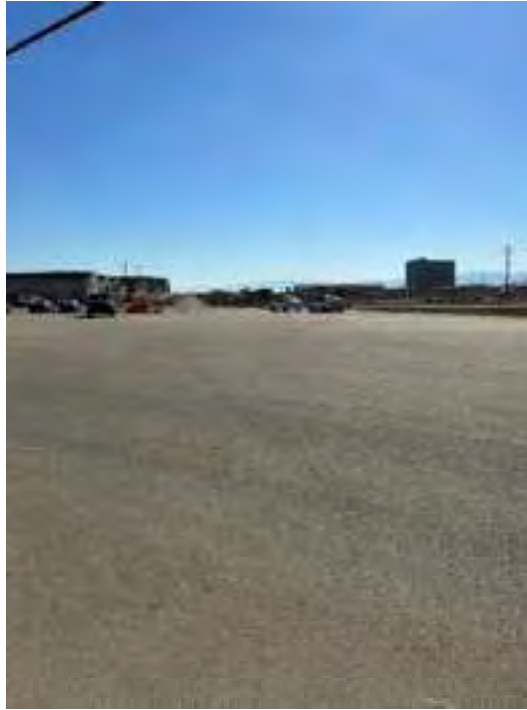
Parcel UC-3 Photograph 7: Asphalt pavement cover between Parcel UC-3 and UC-1.
Facing south.
